DEPARTMENT OF TRANSPORTATION

Contract #: 04-0120F4Cty: SF/ALA Rte: 80 PM: 13.2/13.9File #: 69.28**WELDING INSPECTION REPORT****Resident Engineer:**Pursell, Gary**Address:** 333 Burma Road**City:** Oakland, CA 94607**Report No:** WIR-015421**Date Inspected:** 24-Jun-2010**Project Name:** SAS Superstructure**OSM Arrival Time:** 1900**Prime Contractor:** American Bridge/Fluor Enterprises, a JV**OSM Departure Time:** 700**Contractor:** Zhenhua Port Machinery Company, Ltd (ZPMC), Changxing Island **Location:** Shanghai, China**CWI Name:** See Below**CWI Present:** Yes No**Inspected CWI report:** Yes No N/A**Rod Oven in Use:** Yes No N/A**Electrode to specification:** Yes No N/A**Weld Procedures Followed:** Yes No N/A**Qualified Welders:** Yes No N/A**Verified Joint Fit-up:** Yes No N/A**Approved Drawings:** Yes No N/A**Approved WPS:** Yes No N/A**Delayed / Cancelled:** Yes No N/A**Bridge No:** 34-0006**Component:** OBG**Summary of Items Observed:**

OBG Segment Trial Assembly

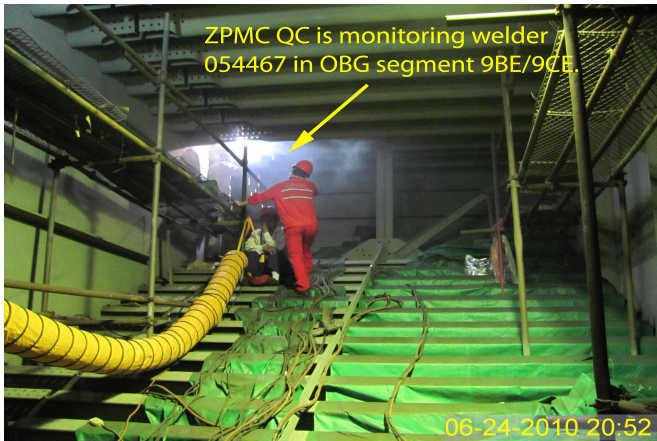
This QA Inspector observed ZPMC welder Mr. Han Yiaofeng, stencil 054467 is using shielded metal arc procedure WPS-B-T-4114-1 to make weld DP697-001-013 and -014 adjacent to where OBG Segment 9BE joins segment 9CE. This QA Inspector measured a welding current of approximately 150 amps, the base material was preheated with a torch prior to welding and Mr. Han Yiaofeng appears to be certified to make this weld. Items observed on this date appeared to generally comply with applicable contract documents. See the photograph for additional information.
